Test Report with XIS-4000 for Butter Box

2020. 03. 10

I. Intellisense Model & Inspection Condition

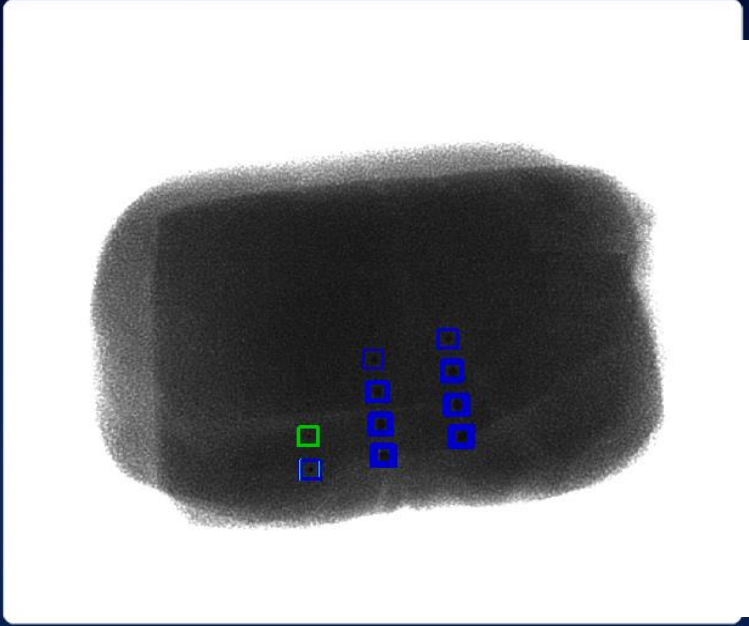
IV. Inspection software image

18/01/06 11:24 0 EA/Minute NONGSHIM ENGINEERING

Condition1	0
Condition2	2
Condition3	2
Condition4	0
Condition5	2
Condition6	0

Setup	Image	Start	Stop	Total Count	2	Reset Count
				O K Count	0	
				N G Count	2	
				Omit Count	0
